**Flood Control Project Maintenance
Levee Inspections**

Maintenance Issue Types Only, Levee Inspection Report By Mile - Spring 2020

Levee District No. 0002 (Glenn County)

Waterway	Bank	Unit Miles	Inspection Start/End	Inspector
Unit No. 01 Glenn County Sacramento River	Right	4.90	03/12/2020 03/12/2020	Makar Sokol

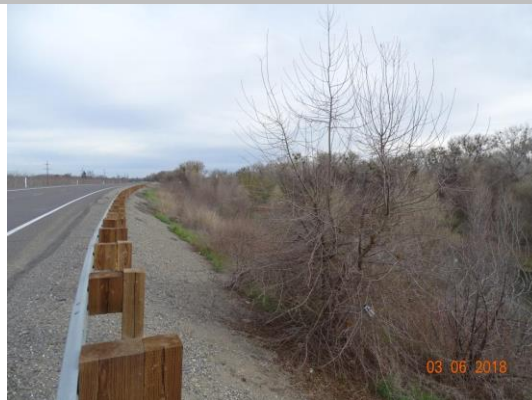
Photo 1 of 1 : SP_2020_LD0002_28_35_20200226_00016.jpg

LM Start	0.64	Rating **	M	Issue No.	35
LM End	0.77	Issue Type +	Ma	Location *	WS
Category	Earthen Levee			GPS Latitude/Longitude	
				Start	End
Item	Vegetation			39.422805 °	39.424597 °
				-122.011640 °	-122.011527 °
DWR ID	DWR_LD0002_01_s_2018_35				
Comment Code					
V2 : Remove the wild growth other than native grasses from the levee slopes.					
Inspector Comment

View of the vegetation along the waterside slope.

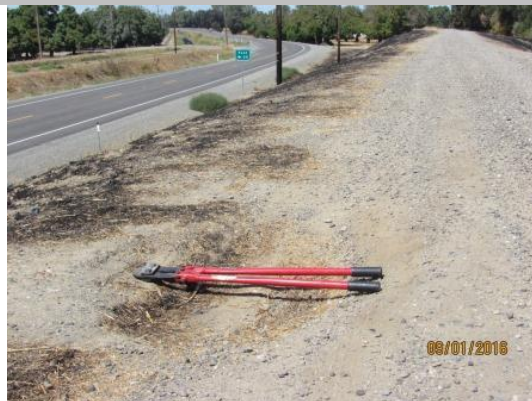
Photo 1 of 1 : SP_2020_LD0002_28_34_20200226_00015.jpg

LM Start	1.40	Rating **	M	Issue No.	34
LM End	1.40	Issue Type +	Ma	Location *	CR
Category	Earthen Levee			GPS Latitude/Longitude	
				Start	End
Item	Crown Surface / Depressions / Rutting			39.433809 °	39.433809 °
				-122.010814 °	-122.010814 °
DWR ID	DWR_LD0002_01_f_2016_34				
Comment Code					
C2 : Repair depressions or ruts in the crown or slope.					
Inspector Comment

View of a depression on the levee crown looking upstream.

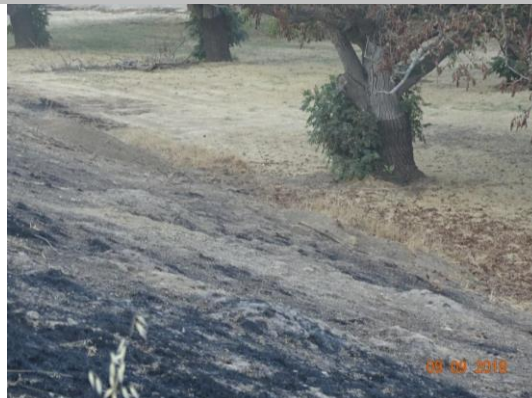
Photo 1 of 1 : SP_2020_LD0002_28_15_20200226_00008.jpg

LM Start	1.52	Rating **	U	Issue No.	15
LM End	1.60	Issue Type +	Ma	Location *	LS
Category	Earthen Levee			GPS Latitude/Longitude	
				Start	End
Item	Animal Control			39.435485 °	39.436643 °
				-122.010640 °	-122.010498 °
DWR ID	DWR_LD0002_01_f_2012_15				
Comment Code					
A3 : No rodents visible, but rodent burrows visible; need to backfill and compact or grout burrows.					
Inspector Comment

View of the rodent holes along the landside slope.

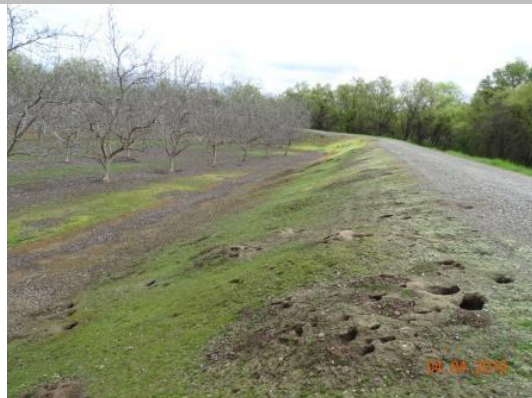
Photo 1 of 2 : SP_2020_LD0002_28_16_20200226_00009.jpg

LM Start	3.24	Rating **	U	Issue No.	16
LM End	3.30	Issue Type +	Ma	Location *	LS
Category	Earthen Levee			GPS Latitude/Longitude	
				Start	End
Item	Animal Control			39.456222 °	39.456272 °
				-122.011266 °	-122.010163 °
DWR ID	DWR_LD0002_01_f_2012_16				
Comment Code					
A3 : No rodents visible, but rodent burrows visible; need to backfill and compact or grout burrows.					
Inspector Comment

View of the rodent holes along the landside slope. Spring 2019.

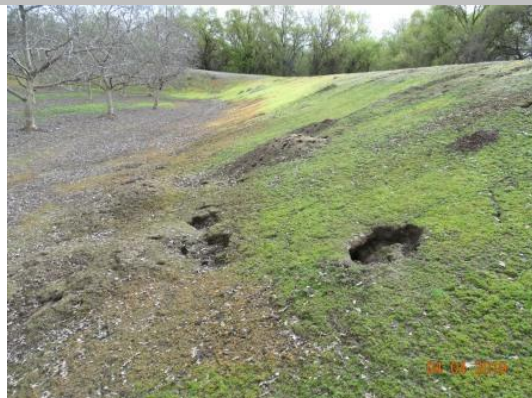
Photo 2 of 2 : SP_2020_LD0002_28_16_20200226_00010.jpg

LM Start	3.24	Rating **	U	Issue No.	16 (cont)
LM End	3.30	Issue Type +	Ma	Location *	LS

Another view of the rodent holes along the landside slope. Spring 2019.

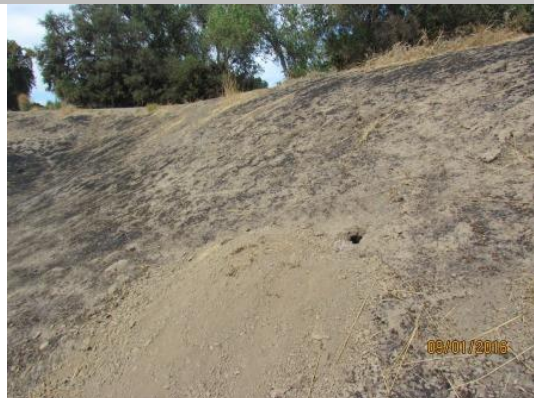
Photo 1 of 2 : SP_2020_LD0002_28_27_20200226_00011.jpg

LM Start	3.44	Rating **	U	Issue No.	27
LM End	3.57	Issue Type +	Ma	Location *	LS
Category	Earthen Levee			GPS Latitude/Longitude	
				Start	End
Item	Animal Control			39.457692 °	39.459305 °
				-122.009517 °	-122.010511 °
DWR ID	DWR_LD0002_01_s_2014_27				
Comment Code					
A3 : No rodents visible, but rodent burrows visible; need to backfill and compact or grout burrows.					
Inspector Comment

View of the rodent holes along the landside slope.

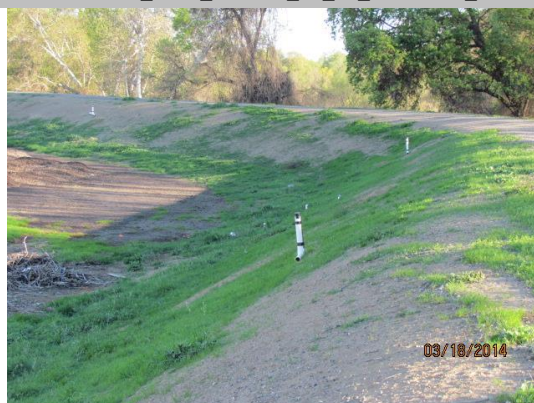
Photo 2 of 2 : SP_2020_LD0002_28_27_20200226_00012.jpg

LM Start	3.44	Rating **	U	Issue No.	27 (cont)
LM End	3.57	Issue Type +	Ma	Location *	LS

View of the rodent activity along the landside slope.

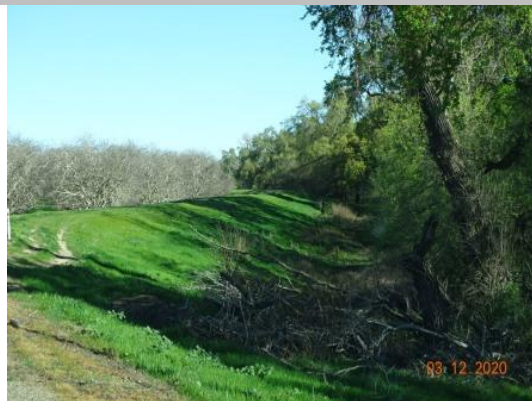
Photo 1 of 1 : SP_2020_LD0002_28_57_20200312_00053.jpg

LM Start	4.90	Rating **	M	Issue No.	57
LM End	4.90	Issue Type +	Ma	Location *	WS
Category	Earthen Levee			GPS Latitude/Longitude	
				Start	End
Item	Encroachments			39.477096 °	39.477096 °
				-122.017607 °	-122.017607 °
DWR ID	DWR_LD0002_01_s_2019_57				
Comment Code					
TR : Tree or limb					
Inspector Comment

View of the tree and branches on the waterside slope. Spring 2020.
